PERFORMANCE AND REPAIR OF THE STRUCTURES OF ROBERT MAILLART

Abstract

This paper discusses the rehabilitation of four Swiss bridges designed by Robert Maillart (1872-1940), well known for his technical innovations and his elegant designs. The bridges served for from 45-66 years before rehabilitation and are currently in service after from 68 to 97 years old.

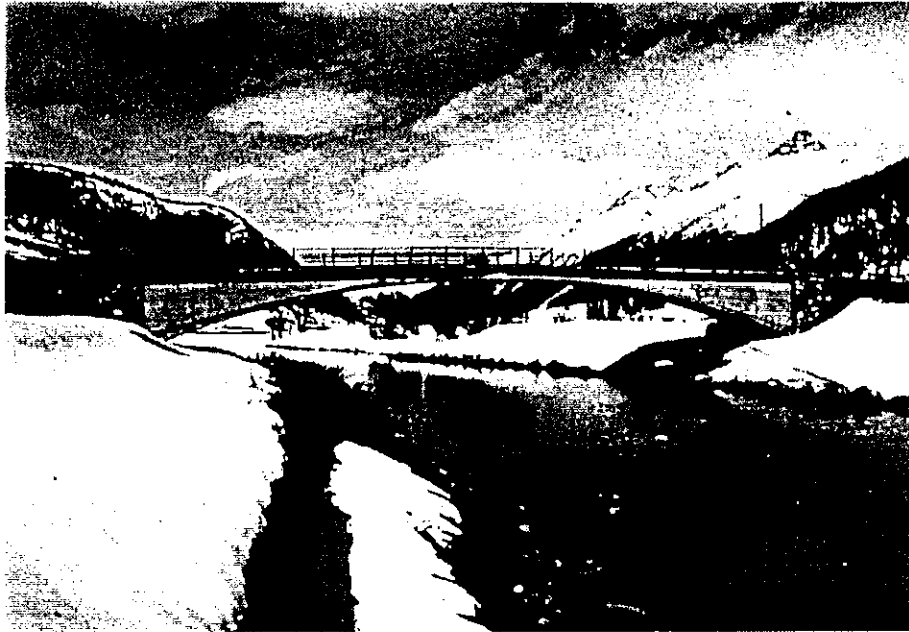
Maillart's first innovation. Cracks in the spandrel walls near the abutments led Maillart to cut out those walls in his 1905 Tavanasa Bridge, the first masterpiece of reinforced concrete design in the 20th century. The Fr. 85,000 renovation of Maillart's Zuoz Bridge centered around the fact that the bridge was an important piece of history and worth preserving. In addition to the arch having sunk and spread 4 cm horizontally on either side, the Zuoz deck and overhangs had suffered significant weathering, with much of the concrete cover having fallen off. The Zuoz Bridge hollow-box, reinforced concrete design still exhibited substantial reserve strength under asymmetric live loads in 1967.[1] Nevertheless, concern that the arch foundations might spread even further led the engineers to anchor them with four 50 ton rock anchors at either end.

Figure 1: Inn River Bridge at Zuoz, 1901
(Fanzun, C., July 1967)

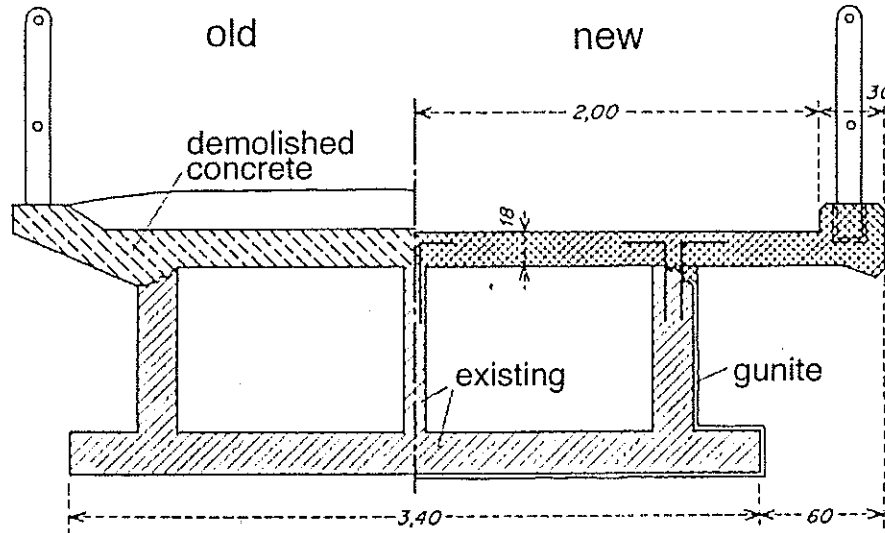
The deck was replaced entirely, also giving a chance to inspect the inside of the hollow box, which had survived in excellent condition.[2] First, the 20 cm cover was removed from the deck, and the deck was subsequently demolished and removed from the bridge. The inside of the hollow box needed almost no repair, and the work consisted mainly of forming, reinforcing and pouring the new deck (Figure 2). Since the original design had been dimensioned for a 6 ton traffic load, and much of the reinforcement had rusted, the engineers specified that the bridge should not be loaded to the modern 12 ton limit. Rehabilitation focused therefore on covering the bridge

Figure 2: Zuoz Bridge deck replacement, 1967
(Favre, R., April 1969)

to prevent further moisture from corroding the structure.[3] This was accomplished by roughing the entire surface of the bridge and then guniting it with concrete.

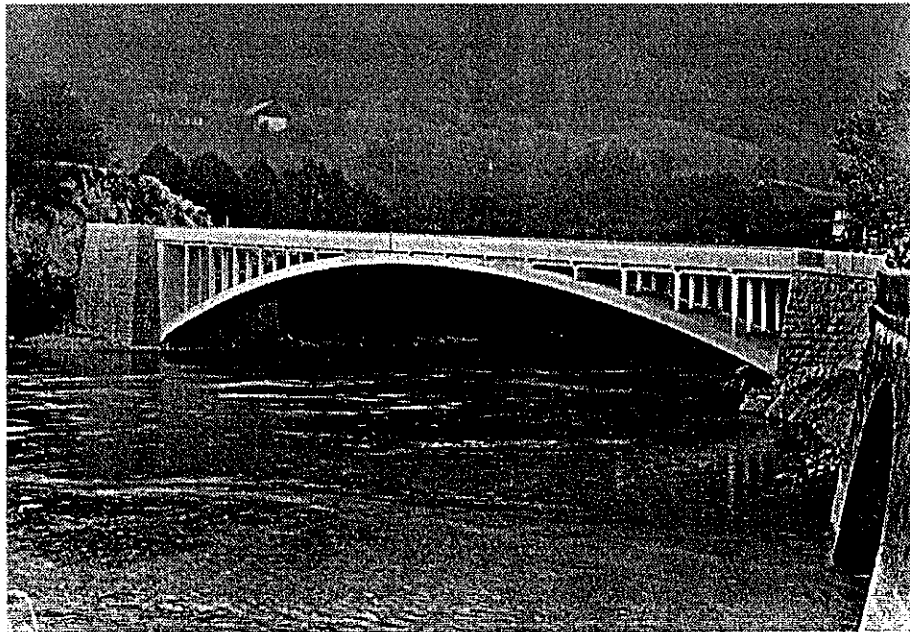
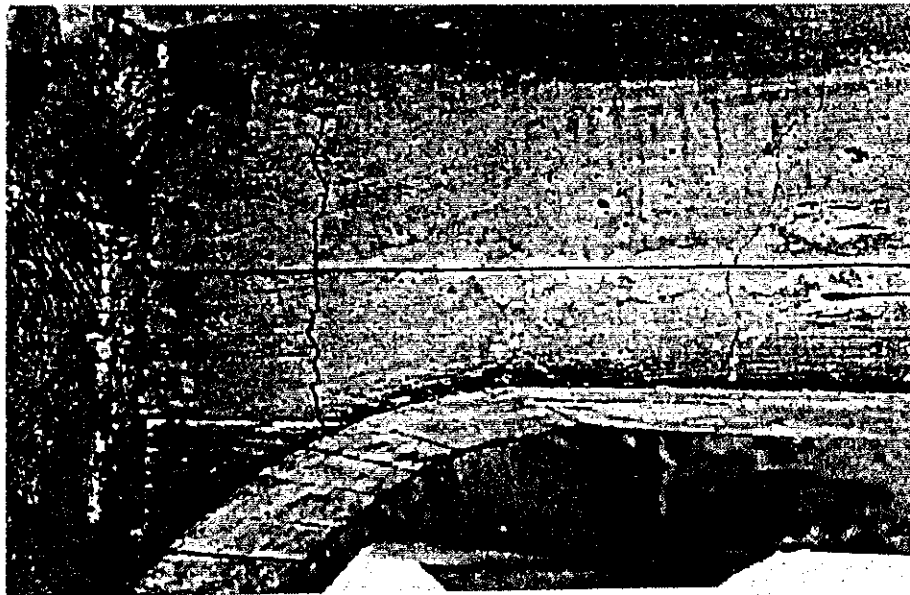
Partly because of cracks in the 1912 Bridge, Maillart was stimulated in 1923 to design the first ever deck-stiffened arch bridge in reinforced concrete, a major innovation which led to his masterpiece of 1933 over the Schwandbach. Engineers in the 1960s debated whether or not to replace the bridge entirely, to replace only the deck while maintaining Maillart's original arch, or to restore the bridge to exactly the condition of Maillart's original construction. It was already clear that the principal danger to the bridge lay in its heavily cracked and corroded deck. In his original design for the Aarburg Bridge, Maillart had assumed the deck to behave as a continuous beam resting on the vertical supports which carried its loads to the 67.9 m long arch. He had therefore reinforced the deck only against negative moments above these supports and against positive moments between them. When the Aarburg deck eventually deflected with the arch under asymmetric loads, an entire side of the bridge was subject to positive bending. These bending moments, resulting from the bridge's global behavior under asymmetric loads, caused cracking in regions of the bridge which had been reinforced based on the assumption of local bending (Figure 3).

Figure 3: Aarburg Bridge, 1912, cracking caused by liveloads
(Maillart et Cie/Billington, D.P., 1979)

In November of 1966, the canton engineers of Aargau had recommend that traffic be reduced from two lanes to one lane, centered on the bridge's longitudinal axis. They recommended that the connection between the vertical supports and the deck be strengthened either by supporting the deck on transverse, vertical walls which carried the full width of the deck, or by strengthening the existing vertical supports with steel angles at each corner.

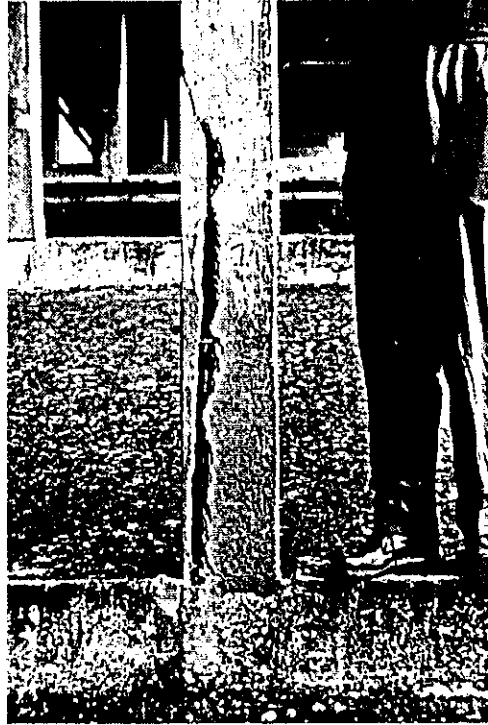
Furthermore, much of the concrete had spalled off, exposing many of the reinforcing bars to further corrosion.[4] Within another year, this carbonation had increased significantly, new cracks were observed and more concrete cover had fallen away due to the expanding reinforcing bars (Figure 4). This accelerating degradation led the engineers to recommend urgently that 16 ton trucks be forbidden to use the bridge until it had been repaired and that if it were not repaired soon it should be shut off from traffic all together.[5]

Figure 4: Aarburg Bridge, exposed reinforcement
(Baudirektion Aargau, 1967)

In 1968 the canton of Aargau decided to replace only the existing deck, widening it from 5.0 to 9.5m. It rejected the other options of replacing the entire bridge or restoring the original 1912 Bridge on the grounds that the first option would cost 50% more than renovation and that the second option would fall victim to the same structural problems as the original bridge. Citing later Maillart bridges such as the Salginatobel and the Rossgraben, the engineers defended their choice of renovation to a more rational design because it not only stiffened the bridge against buckling and vibrations but also avoided loading the arch near the supports where its curvature was flattest. In addition, the engineers had decided to prestress the new deck transversely due to its widening. Since grooves had to be cut in the arch for the placement of vertical stiffening walls, the engineers also

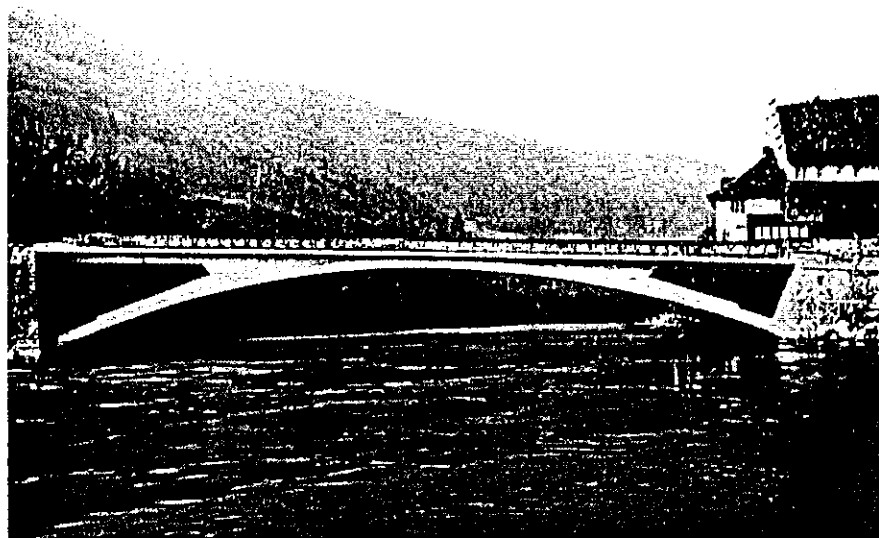
The bridge was reopened on November 19, 1968, only six months after construction had begun (Figure 5). With the arch already in place, there was no need for extensive scaffolding. The proposed cost of Fr. 790,000 had fallen to Fr. 600,000 thanks to intensive planning and a simplified construction procedure. The canton of Aargau paid 2/3 of this cost, 20% of which was paid by the town of Aarburg, while the canton of Solothurn paid the remaining 1/3. The engineers treated Maillart's Aarburg Bridge as a monument, worthy of great care and respect. "It is of course too bad that Maillart could not renovate his bridge himself, but we may hope that he would not have done it differently than we have."[7]

Figure 5: New Aarburg Bridge, 1968
(Favre, R., April 1969)

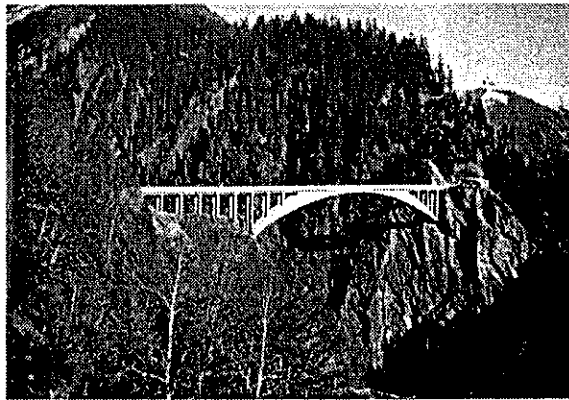
Besides the badly worn hinge on the Schudders side which had collected water due to the explosives box attached to it, the entire deck needed to be strengthened and a concrete overlay added.[12] The 6 cm wearing surface as well as some of the concrete from the original deck were removed and replaced by 8 cm of new, reinforced concrete which gave the deck a new structural depth of 18 - 22 cm. The new deck received then a layer of insulation and 3 - 4 cm of new asphalt. In addition, a 10 cm width of the semicircular openings in the parapet were filled in with concrete, preventing runoff from dripping on the arch but still leaving a visual imprint of the original openings on the elevation view.

Figure 7: Salginatobel Bridge, new deck, 1975
(Maillart)
